1-1-5-3 導体貼付断線／导线转移的开路 / Open by torn-off and stuck conductor

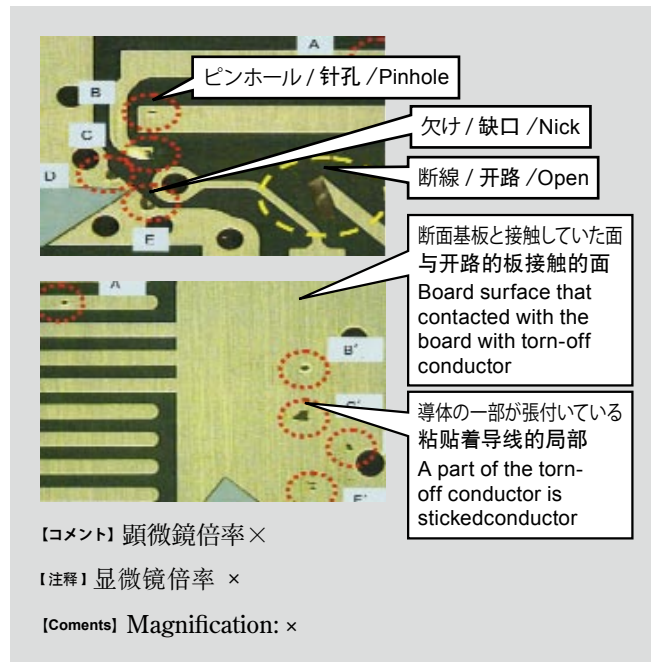
【特徴】 欠けやピンホールなど同居し、重なっていた配線板の接触面の相対位置には、剥ぎ取られた導体が付着している状態の欠陥

【Characteristics】 A nick, a pinhole or the like of conductor on a panel and the stuck conductor on another panel form the open. The position of a stuck conductor on a panel coincides with the corresponding position of a nick or the like on the opposite panel of stacked panels.

【原因・判断ポイント・発生工程】 間紙を挟まずに配線板を高く重ねたため、自重による過度の負荷が加わり導体同士が圧着して、引き剥がす際に片側の導体が引き剥がされて出来たもの（回路形成後～レジスト塗布前工程）

When many panels are stacked without using separating paper, conductors on adjacent panels are stuck to each other because of the excessive load induced by their weight. When separating the panels, pieces of conductor on a panel are torn off and stick to the facing another panel. (After forming conductor pattern - before solder resist application)
