1-5-3-4 レーザ穴突起／激光孔的凸出 / Projected conductor from laser drilled hole

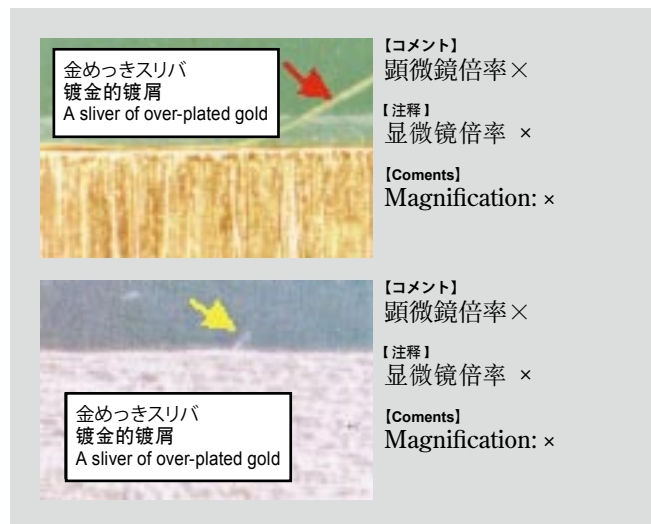
【原因、判断要点、发生工序】在 ET 剂的焊料或者镀金层的镀层突沿有针形细片的模样，即将从导线边缘剥落所引起的。如果导线 ET 过度，就容易产生(ET 工序、表面处理工序)。

【Causes/processes involved/keys to judgment】

An overhang after etching of solder or over-plated gold used as for metal etching resist is partially separated in the form of a fine needle from the edge of a conductor. The defect is likely to occur, when conductive pattern is over-etched. (Etching - surface finishing process)

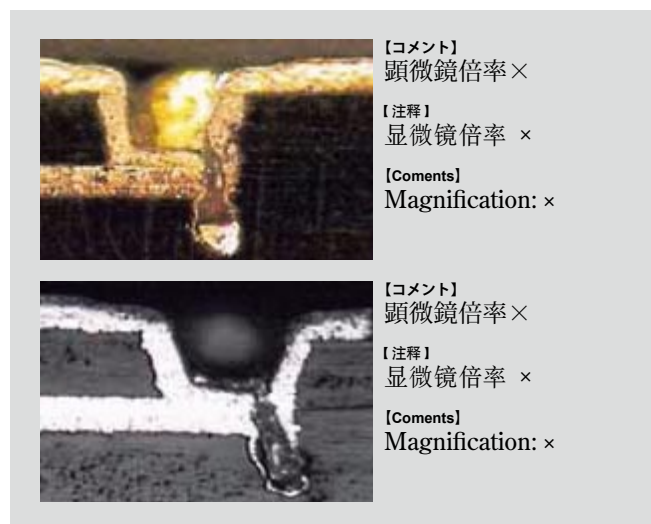
【特徴】 ブラインドスルーホール底の部分が破れたような形状で銅めっきが飛び出している突起

【特征】 盲孔底の局部破裂，镀铜层鼓起的凸出。

【Characteristics】 Plated copper plating is projected downward from the bottom of a blind through hole, as if the bottom is ruptured.

【原因・判断ポイント・発生工程】 ビア下ランドとスルーホールの相対位置がずれたことによりレーザー穴がビア下ランドからはみ出したため、その部分に銅めっきが析出して出来たもの（ビルドアップ積層工程、レーザー穴明け工程、スルーホールめっき工程）

【原因、判断要点、发生工序】 由于导通孔下边的焊环与通孔的相对位置偏移，激光孔超出导通孔下边的焊环，在该部位沉积铜所引起的（积层层压工序、激光钻孔工序、镀通孔工序）。

【Causes/processes involved/keys to judgment】

Imperfect registration of drilled hole to via-bottom land causes the laser drilled hole to pierce the via-bottom land. Copper is deposited at this spot to form a projection. (Build-up lamination, laser drilling and through hole plating process)
