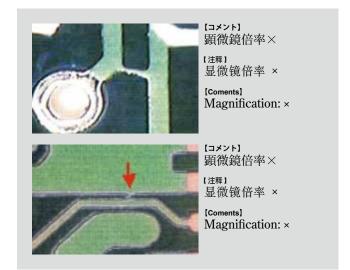
【原因・判断ポイント・発生工程】ネガタイプAWFの不透明部に付いた傷部が露光して出来たもの(AWF作製後~ET工程)

【原因、判断要点、发生工序】对 AWF 不透明区有 伤痕部位曝光时所引起的(AWF 制作后~ET 工序)。

Exposure is made with a phototool with a scratch on the opaque area of the negative pattern causing the defect. (Preparation of phototool - etching process)

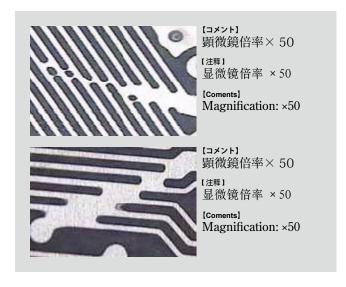
## 1-8-3-6 繊維状異物介在露光被り短絡/纤维杂物妨碍曝光的短路/ Short by photographic fogging by an adhered fibrous object

【特徴】複数の回路線にまたがって、比較的長く短絡している状態の欠陥、めっき面の凹凸は認められない

【特征】跨过多条线路比较长的短路缺陷,而不是镀层面的凹凸。

**[Characteristics]** A short of a relatively long distance extending several conductors. Unevenness of the plated surface is not observed.

【原因・判断ポイント・発生工程】DFRとAWF間に介在した繊維状異物により、AWFが浮き上がり状態となり、露光被りして出来たもの(露光工程~ET工程)

【原因、判断要点、发生工序】DFR 和 AWF 之间夹杂纤维杂物,AWF 鼓起而妨碍曝光所引起的(曝光工序~ET 工序)。

Photographic fogging caused by lift of a phototool by a fibrous foreign object between dry film and a phototool generates the defect. (Exposure – etching process)
