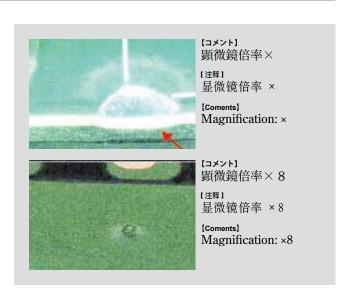
2-1-2-4 SR 打痕/SR 的压痕/Dent on solder resist

【特徴】SR表面に凹み状の衝突打痕が残されている状態の欠陥

【特征】SR 表面有凹陷的碰撞压痕的缺陷。

[Characteristics] A dent by an impact is left on the solder resist surface.

【原因・判断ポイント・発生工程】 S R塗布乾燥後のハンドリング作業時に、不注意に何かにぶつけて出来たもの(SR塗布乾燥後工程)

【原因、判断要点、发生工序】涂布 SR 后的搬运作业时,不小心碰撞某种物体而引起的(SR 烘干后工序)。

[Causes/processes involved/keys to judgment]

The solder resist surface is carelessly hit by some object during handling after solder resist coating and curing. (After solder resist coating and curing process)
