## 2-2-2-2 異物剥離部 SR 不付き/杂物剥落部位的 SR 不粘结 / Solder resist missing at a peeled foreign object

## 2-2-2-3 PSR 未露光部不付き/ PSR 未曝光部位的剥落/ Photo solder resist missing caused by a foreign object

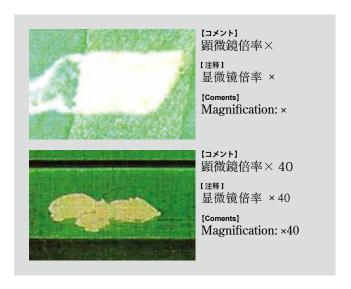
【特徴】SRが異物形状どおりについていない状態の欠陥

**[Characteristics]** Solder resist does not coat over an iron base board not exactly in the form of a foreign object once existed.

【原因・判断ポイント・発生工程】SR塗布時に板面に介在した異物が、SR塗布を妨げ、かつSR乾燥後に剥離したことにより出来たもの(SR塗布~乾燥後工程)

A foreign object existing on a board at the time of solder resist application prevents solder resist coating and is partially peeled off after solder resist curing, causing the defect. (Solder resist application process)
