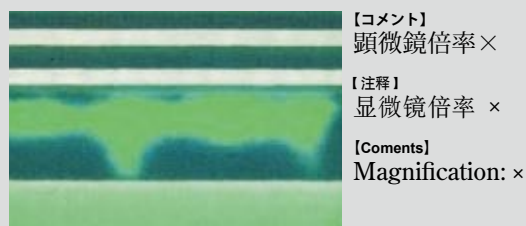
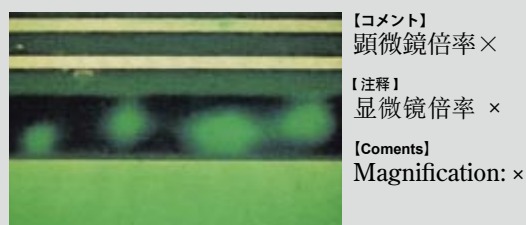
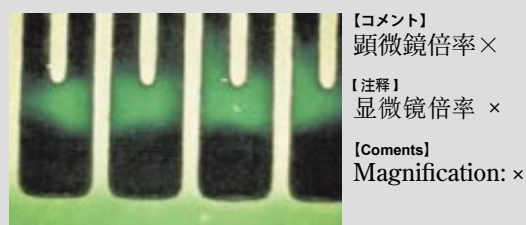
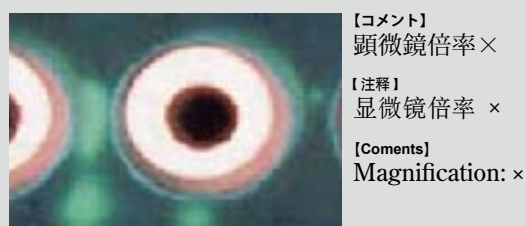
【特徴】SR 塗布面に白雲状の変色が見られる状態の欠陥

【特征】在SR 涂布面有白云形状的变化色的缺陷。

【Characteristics】Cloud-like discolouration appears on the coated solder resist surface.

【原因・判断ポイント・発生工程】SR 塗布の際、SR インクが塗布面に十分に充填されずに空隙が閉じ込められて出来たもの

【原因、判断要点、发生工序】在SR 涂布时，SR 油墨不能充分地填充涂布面，存在空穴而引起的（SR 涂布工序）。

【Causes/processes involved/keys to judgment】The filling of solder resist ink to the area to be coated is not sufficient and a void is left on the surface. (Solder resist coating process)
