4-2-1-10 金めっき端子打痕/镀金插脚的压痕/ Dent on gold plated edge board contact

4-2-2 めっき条件管理不良起因(金めっき欠陥)/电镀条件的管理不善(镀金层缺陷)/ Caused by improper plating condition(gold plating defects)

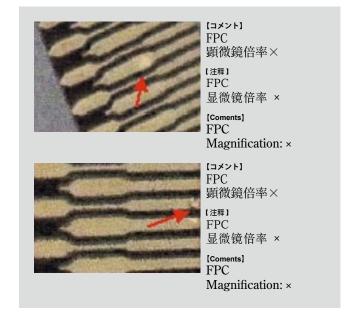
【特徴】金めっき端子表面に打痕が認められる状態 の欠陥

【特征】镀金插脚表面有压痕的缺陷。

[Characteristics] The surface of a gold plated edge board contact is dented.

【原因・判断ポイント・発生工程】プレス打ち抜き 外形加工などの際金めっき端子上に異物が介在した ため出来たもの(打ち抜きプレス加工工程)

【原因、判断要点、发生工序】冲切外形时镀金插脚上夹杂杂物所引起的(冲切工序)。

[Causes/processes involved/keys to judgment]

The defect is caused by the presence of a foreign object on a gold plated edge board contact when outlining by board punching (Punching process)
