1-5-1-13 CF 接着剤残り突起/CF 粘着剂屑的凸出/ Projected conductor by debris of carrier film adhesive

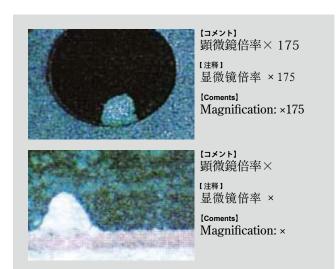
【特徴】UTCのCF接着剤の下にUTCの銅箔が 残っている突起

【特征】在 UTC 的 CF 粘着剂的下面残留 UTC 铜箔的凸出。

[Characteristics] A projection of UTC foil copper remaining under adhesive of UTC carrier film

【**原因・判断ポイント・発生工程**】 UTC積層時の 積層条件異常等で、CF剥離時に残った接着剤がETレジストとなり、UTC銅箔が残ってできたもの (CF付きUTC積層・CF剥離~ET工程) UTC: Ultra Thin Copper (極薄銅箔)

【原因、判断要点、发生工序】在 UTC 层压时,由于层压条件异常等,CF 剥离时留下的粘着剂屑成为 ET剂,并粘附在 UTC 铜箔上而引起的 (CF的 UTC 层压·CF剥離~ET工序)UTC Ultra Thin Copper (极薄铜箔)。

Adhesive remains after removing carrier film due to an abnormal lamination condition for UTC lamination. The adhesive residue acts as an etching resist to leave the UTC foil copper unremoved. (Lamination of UTC with carrier film, carrier film removal, etching process)
